Case 359 : Narrative

Case Vehicle (A): 2000 Lincoln
Type: LS, 4-door sedan
Driver: 29-year-old female
CDC: 12-FCEW-3

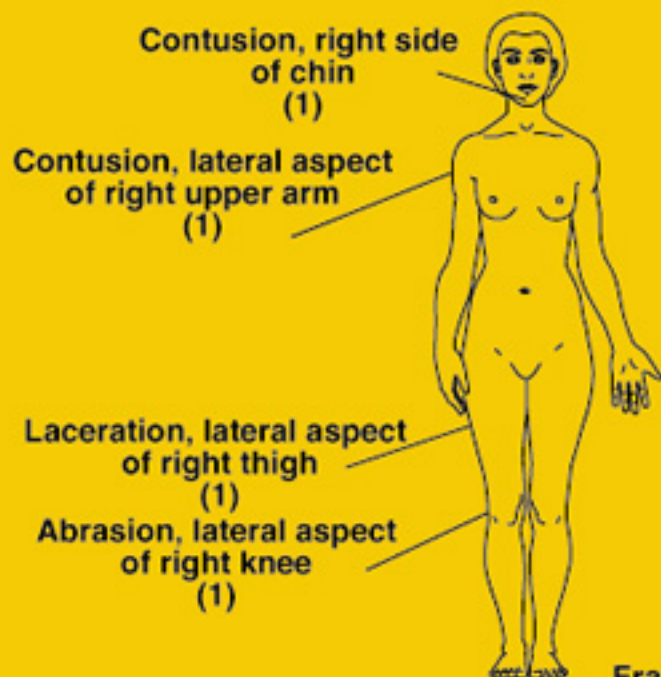
Fracture and dislocation,
distal aspect of right tibia
(pilon fracture)
(2)
